# **INDOOR AIR QUALITY ASSESSMENT**

**Old Rochester Regional Junior High School  
133 Marion Road  
Mattapoisett, Massachusetts**

Prepared by:  
Massachusetts Department of Public Health  
Center for Environmental Health  
Emergency Response/Indoor Air Quality Program  
December 2004

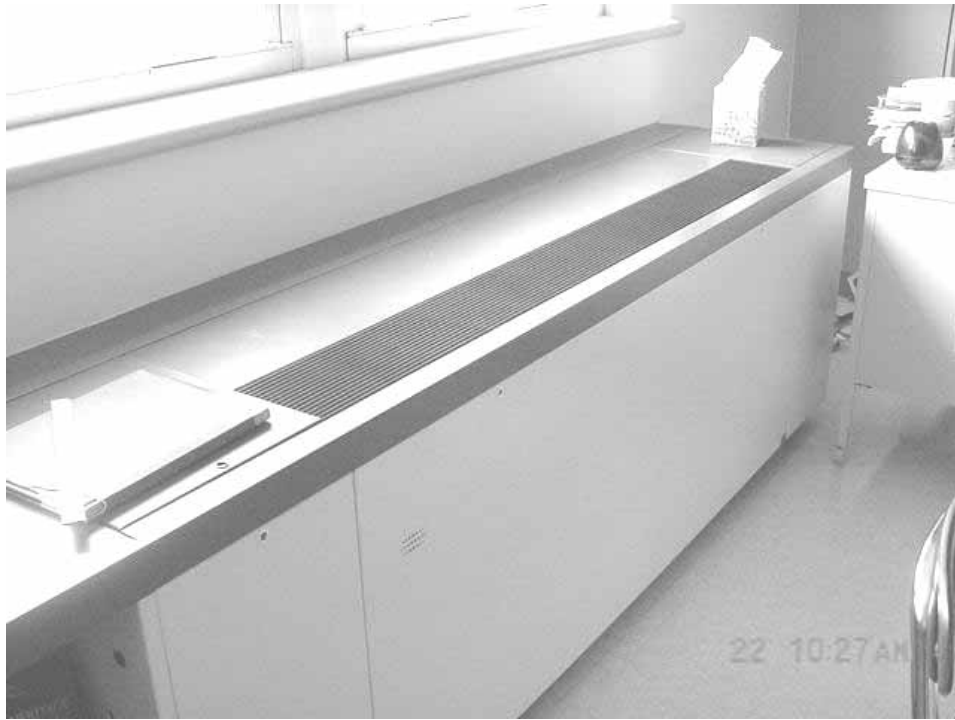
**Picture 1**

It can be seen from Table 1 that carbon dioxide levels were elevated above 800 parts per million (ppm) in seven of fifty-two areas, indicating adequate ventilation in the majority of areas surveyed. Fresh air in classrooms is supplied by a unit ventilator (univent) system (Picture 1). A univent draws air from outdoors through a fresh air intake located on the exterior walls of the building and returns air through an air intake located at the base of the unit ([Figure 1](#)). Fresh and return air are mixed, filtered, heated and/or cooled and provided to classrooms through a diffuser located on the top of the unit. Adjustable louvers control the ratio of fresh and recirculated air. Obstructions to airflow, such as furniture located in front of and/or materials stored on univents, were

observed in some areas. In order for univents to provide fresh air as designed, these units must remain free of obstructions.

**Classroom Univent**

4. Examine each univent for function. Survey classrooms for univent function to ascertain if an adequate air supply exists for each room. Operate univents while classrooms are occupied.

5. Remove all blockages from univents and exhaust vents.
6. Continue to operate both supply and exhaust ventilation continuously during periods of school occupancy. To maximize air exchange keep classroom doors shut.

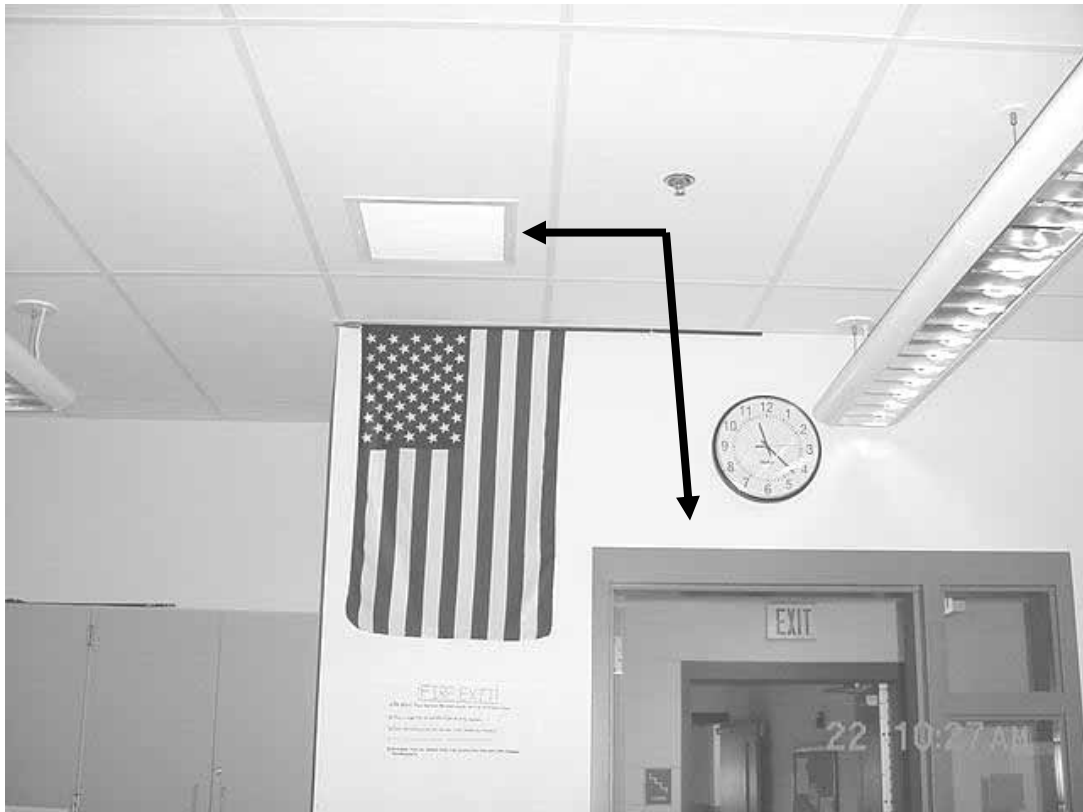
**Picture 2**

The mechanical exhaust ventilation system in classrooms consists of ceiling-mounted vents connected to rooftop fans. This system was operating during the assessment. It is important to note that the location of some exhaust vents can limit exhaust efficiency. In some classrooms, exhaust vents are located above hallway doors (Picture 2). When classroom doors are open, exhaust vents will tend to draw air from both the hallway and the classroom. The open hallway door reduces the effectiveness of the exhaust vent to remove common environmental pollutants from classrooms.

**Classroom Exhaust Vent, Note Proximity to Open Hallway Door**

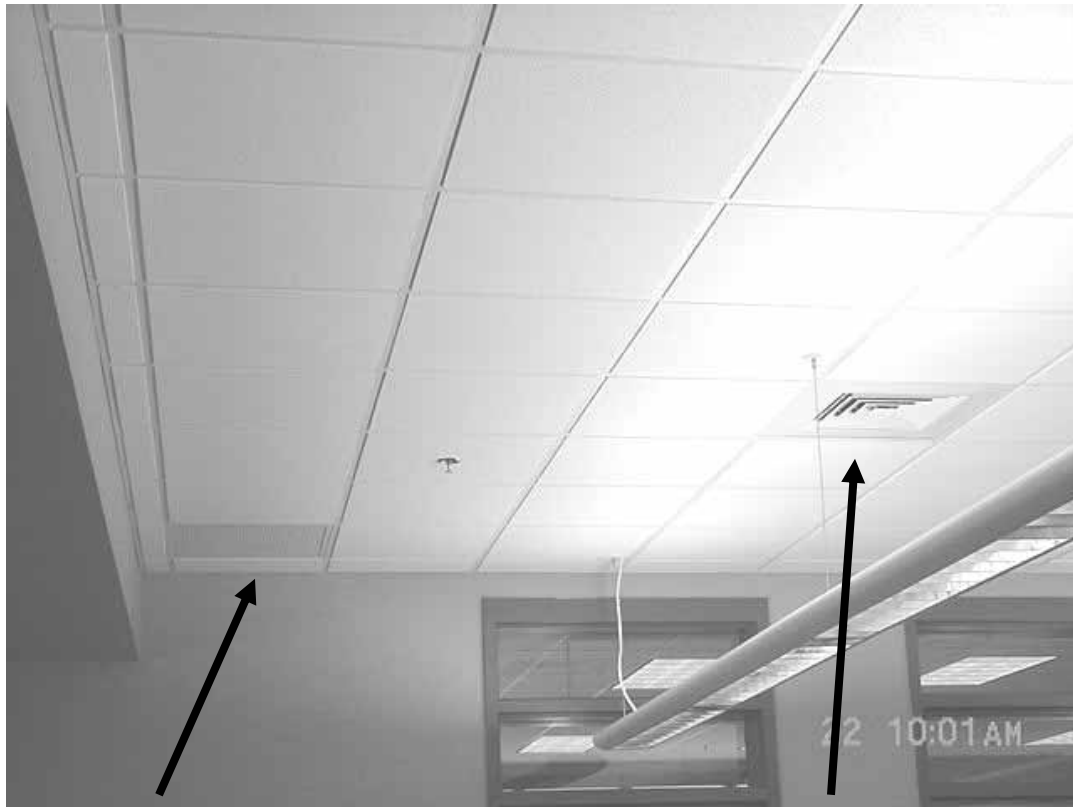
**Picture 3**

Common areas throughout the building (cafeteria, gymnasium, library) are ventilated by air handling units (AHUs). Fresh heated/cooled air is supplied through ceiling mounted air diffusers and ducted back to the AHUs via return vents (Picture 3). Elevated levels of carbon dioxide were detected in the gymnasium while unoccupied (Table 1), indicating lack of air exchange. BEHA staff found that wall-mounted exhaust vents in the gym were not drawing air. Without proper exhaust ventilation, environmental pollutants can build up (e.g., carbon dioxide) in the indoor environment and lead to indoor air quality complaints. Mr. Shiraka reported to BEHA staff that the school department's HVAC vendor had provided them with an incomplete software package, which interfered with proper control of the systems. It was also reported that software upgrades had been ordered to improve both ventilation and comfort control.

**Supply Diffuser and Return Vent for HVAC System in Library**

1. Continue with plans to make software upgrades to gain control of HVAC system.
2. Develop a notification system for building occupants to report ventilation/comfort complaints.

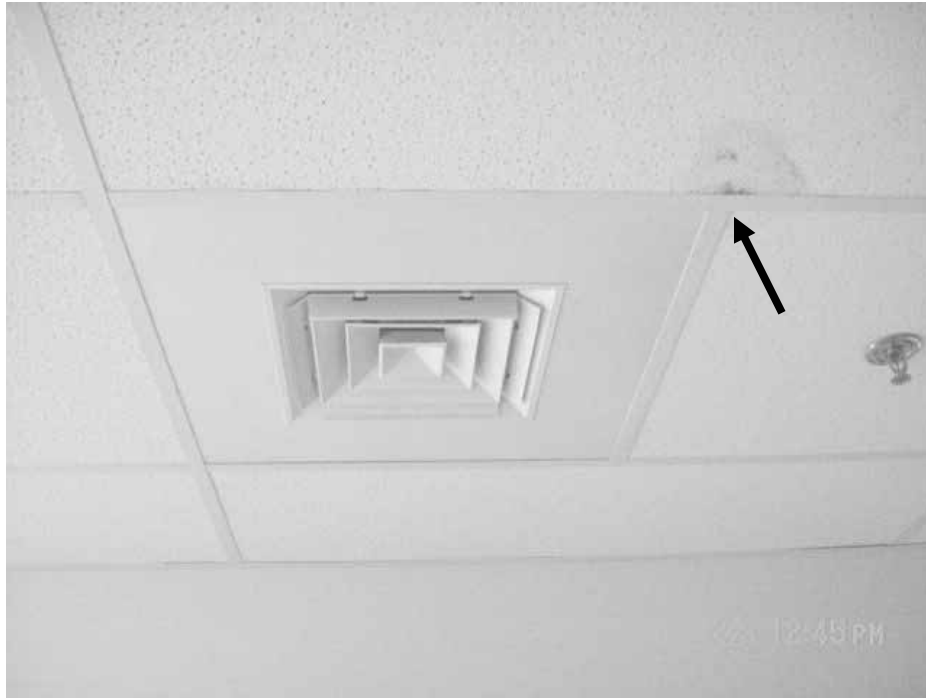
**Picture 4**

BEHA staff identified possible mold growth on a ceiling tile in guidance office 3 (Picture 4); BEHA staff recommended that this tile be removed. The guidance office

room was unoccupied during the assessment due to reports of reoccurring sewer gas odors, which will be discussed further in this report. Hallways and classrooms in other portions of the building also had water damaged ceiling tiles (Table 1). These ceiling tiles appear to have sustained damage from leaks in the air conditioning/drainage system rather than from roof leaks. Water-damaged ceiling tiles can provide a source of mold and should be replaced after a water leak is discovered and repaired.

Lastly, as discussed by school officials, the guidance office has been experiencing re-occurring sewer gas odors. The point source of the odors appeared to be a broken pipe located below the concrete floor in Guidance Office 3. The Old Rochester Regional School Department has reportedly contracted a plumbing contractor to drain the pipe once a month until the pipe can be excavated (tentatively scheduled for the summer of 2005). In the interim, the room has been temporarily vacated.

**Supply Vent in Guidance Office 3, Note Water Damaged Ceiling Tile with Possible Mold Growth**

8. Ensure roof and/or plumbing leaks are repaired, and replace any remaining water-stained/missing ceiling tiles. Examine the space above and around these areas for mold growth. Disinfect areas of water leaks with an appropriate antimicrobial.

14. Continue with plans to repair the faulty sewer line. To reduce odors in the interim, seal the doors as airtight as possible using plastic and duct tape to create a barrier. To prevent odors from entering the general ventilation system, where they can be distributed to other areas of the building the supply and return vents should be temporarily sealed.

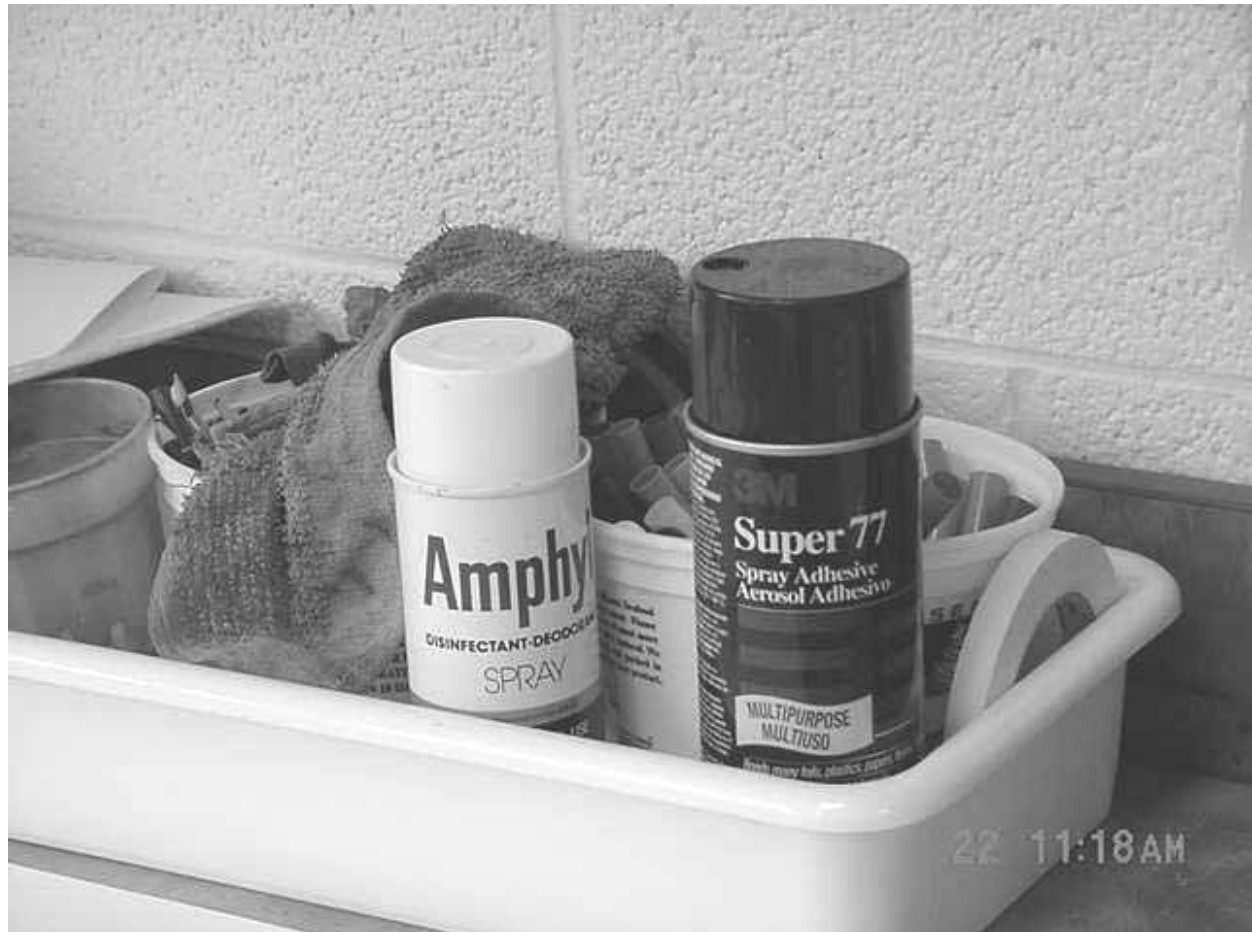
**Picture 5**

Please note, TVOC air measurements are only reflective of the indoor air concentrations present at the time of sampling. Indoor air concentrations can be greatly impacted by the use of TVOC-containing products. While no measurable TVOC levels were detected in the indoor environment, VOC-containing materials were noted. Several classrooms contained dry erase boards and dry erase board markers. Materials such as dry erase markers and dry erase board cleaners may contain VOCs, such as methyl isobutyl ketone, n-butyl acetate and butyl-cellusolve (Sanford, 1999), which can be irritating to the eyes, nose and throat. Cleaning products were found on countertops and beneath sinks in a number of classrooms (Picture 5). Cleaning products contain VOCs and other

chemicals, which can be irritating to the eyes, nose and throat and should be stored properly and kept out of reach of students.

**Spray Cleaning Products in Classroom**

11. Store cleaning products properly and out of reach of students.
12. Clean univent air diffusers and exhaust vents periodically of accumulated dust.
13. Relocate or consider reducing the amount of materials stored in classrooms to allow for more thorough cleaning. Clean items regularly with a wet cloth or sponge to prevent excessive dust build-up.
